Manhole Inspection Summary

Manhole # S45E2_007MH

Insp Date: **12/31/07 7:53 AM**

Location Address: **3900 Pascal Ave**

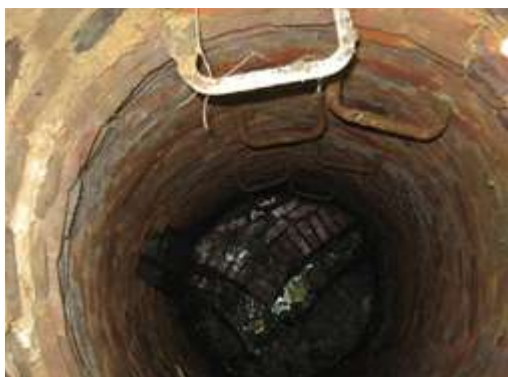
Defect 1

steps

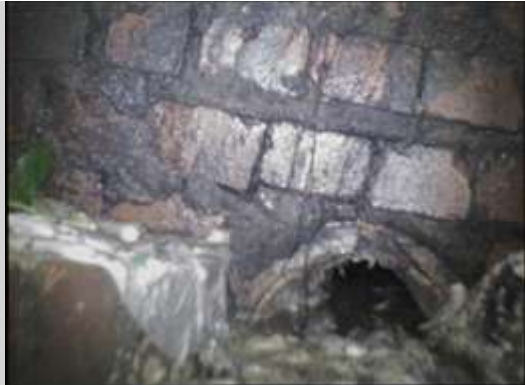
12 O'Clock Outflow

8 in. Circular Gravity Sewer
Pipe Out @ 12 O'Clock

Pipe Height: **10.8** (in.) Rod and Bar (Angled)
Pipe Material: **Clay** ☐ Pipe Lined
Invert Depth: **12.38** (ft.) Flow Characteristics: **Slow**
Deposits: ☐ None ☐ Mud ☐ Sludge ☒ **Debris** ☒ **Grease**
Silt Depth: **3** (in.) Deposits Extent: **Heavy**
Infiltration: **None** Pipe Seal Cond: **Sound**

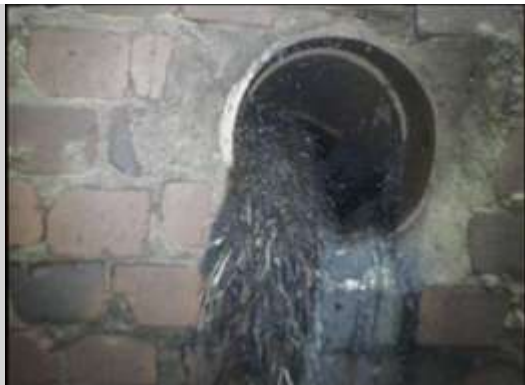
4 O'Clock Inflow

8 in. Circular Gravity Sewer
Pipe In @ 4 O'Clock

Pipe Height: **9.6** (in.) Rod and Bar (Angled)
Pipe Material: **Clay** ☐ Pipe Lined
Invert Depth: **6.80** (ft.) Flow Characteristics: **Slow**
Deposits: ☐ None ☐ Mud ☐ Sludge ☒ **Debris** ☐ **Grease**
Silt Depth: **3** (in.) Deposits Extent: **Medium**
Infiltration: **None** Pipe Seal Cond: **Sound**

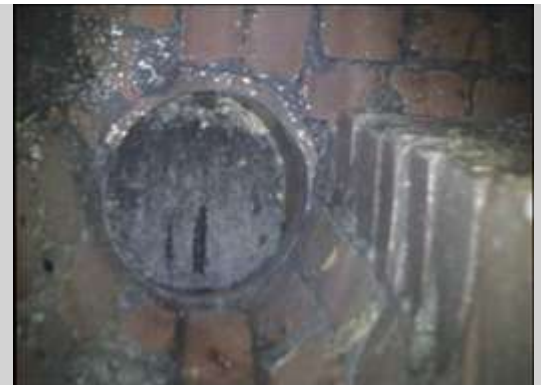
Drop In @ 4 O'Clock

Drop: **Inside** Rod and Bar
Angled: **Yes** Reading: **10.86** (ft.)
Inv Depth: **11.86** (ft.)
Drop Condition: **Open**

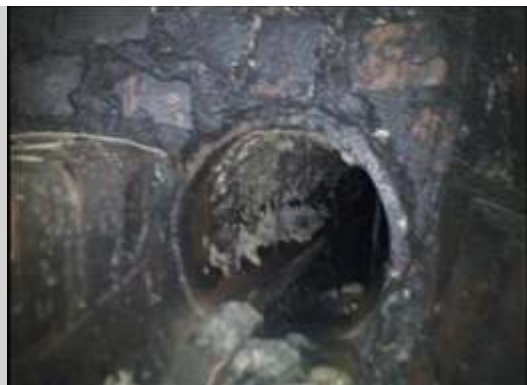
8 O'Clock Inflow

Pipe In @ 8 O'Clock

Deposits: ☐ None ☐ Mud ☐ Sludge ☐ Debris ☒ **Grease**

Silt Depth: **1** (in.) Deposits Extent: **Light**
